ASBESTOS INSPECTION REPORT

Inspection Date : 28 AUGUST 2007

Report Number : 23896

SITE: 40 DESHON STREET, WOOLLOONGABBA QLD **NAME:** KEVIN POWER **DATE:** 28 AUGUST 2007

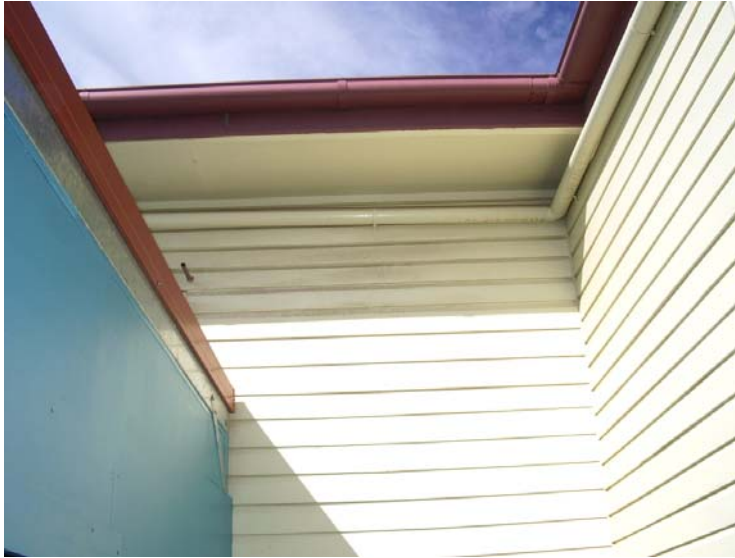
PHOTO 2

| TYPES AND FORMS OF ASBESTOS PRODUCTS/MATERIAL | FRIABLE | BONDED | SAMPLE TAKEN | | | PHOTO No. | SUSPECTED | | ABESTOS TYPE | CONDITION | PRIORITY | APPROX QUANTITY AREA/LENGTH Eg (Sq. M) |
|---|---|---|---|---|---|---|---|---|---|---|---|--|
| FIBRE CEMENT FLAT SHEET | | ✓ | 23896-1 | | | 02 | ✓ | | CH | G | M | 15.0M SQUARE |
| LOCATION/NOTES | SOFFIT SHEET AND GABLE SHEET | | | | | | | | | | | |

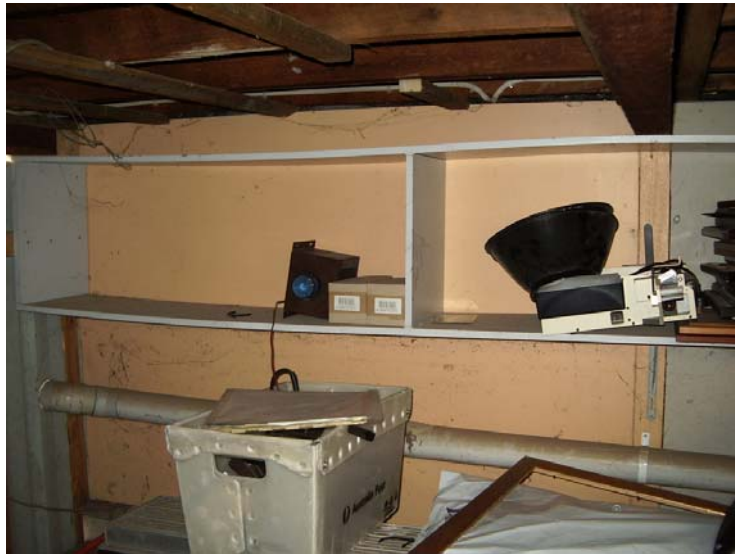
PHOTO 3

| TYPES AND FORMS OF ASBESTOS PRODUCTS/MATERIAL | FRIABLE | BONDED | SAMPLE TAKEN | | | PHOTO No. | SUSPECTED | | ABESTOS TYPE | CONDITION | PRIORITY | APPROX QUANTITY AREA/LENGTH Eg (Sq. M) |
|---|---|---|---|---|---|---|---|---|---|---|---|--|
| FLAT SHEET FIBRE CEMENT | | ✓ | 23896-2 | | | 03 | ✓ | | NAD | G | M | 12.0M SQUARE |
| LOCATION/NOTES | SUBFLOOR WALL SHEETING | | | | | | | | | | | |

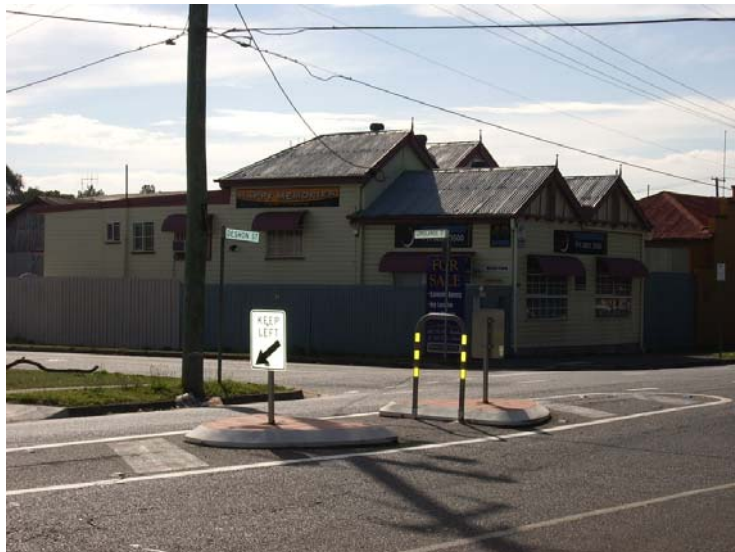
PHOTO 4

| TYPES AND FORMS OF ASBESTOS PRODUCTS/MATERIAL | FRIABLE | BONDED | SAMPLE TAKEN | | | PHOTO No. | SUSPECTED | | ABESTOS TYPE | CONDITION | PRIORITY | APPROX QUANTITY AREA/LENGTH Eg (Sq. M) |
|---|---|---|---|---|---|---|---|---|---|---|---|--|
| FIBRE CEMENT FLAT SHEET | | ✓ | 23896-3 | | | 04 | ✓ | | CH | F | H | 8.0M SQUARE |
| LOCATION/NOTES | GABLE END CENTRE OF BUILDING | | | | | | | | | | | |

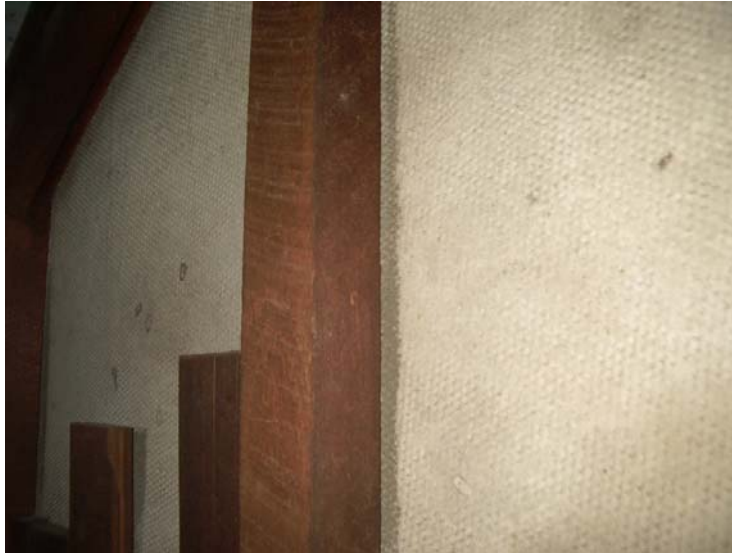
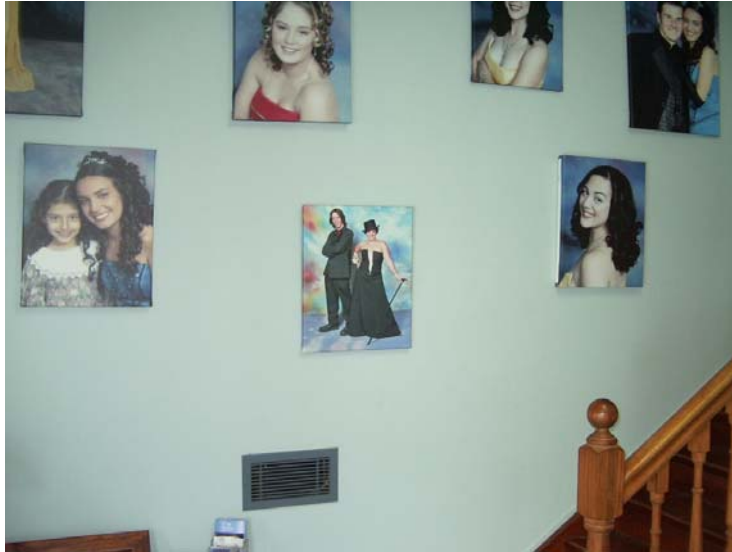
PHOTO 5

| TYPES AND FORMS OF ASBESTOS PRODUCTS/MATERIAL | FRIABLE | BONDED | SAMPLE TAKEN | | | PHOTO No. | SUSPECTED | | ABESTOS TYPE | CONDITION | PRIORITY | APPROX QUANTITY AREA/LENGTH Eg (Sq. M) |
|---|---|---|---|---|---|---|---|---|---|---|---|--|
| FLAT SHEET FIBRE CEMENT | | ✓ | 23896-4 | | | 05 | ✓ | | NAD | G | M | 65.0M SQUARE |
| LOCATION/NOTES | CONFERENCE ROOM / WAITING ROOM | | | | | | | | | | | |

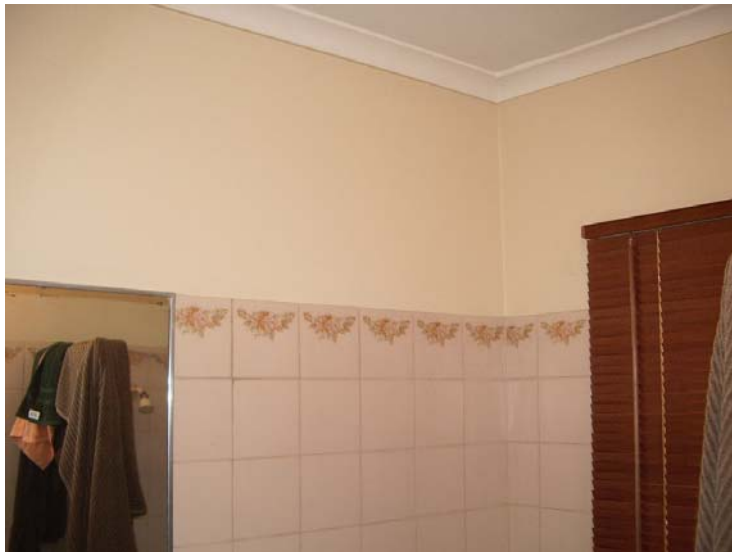
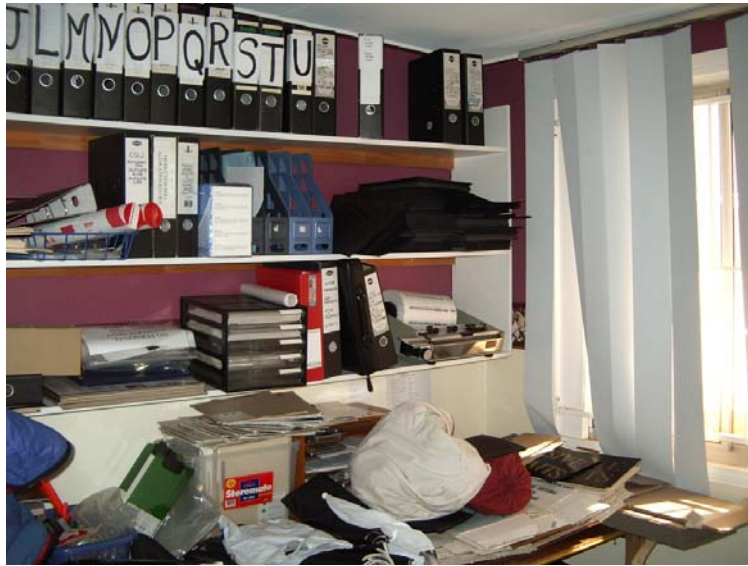
PHOTO 6

| TYPES AND FORMS OF ASBESTOS PRODUCTS/MATERIAL | FRIABLE | BONDED | SAMPLE TAKEN | | | PHOTO No. | SUSPECTED | | ABESTOS TYPE | CONDITION | PRIORITY | APPROX QUANTITY AREA/LENGTH Eg (Sq. M) |
|---|---|---|---|---|---|---|---|---|---|---|---|--|
| FIBRE CEMENT FLAT SHEET | | ✓ | 23896-5 | | | 06 | ✓ | | CH | G | M | 25.0M SQUARE |
| LOCATION/NOTES | REAR ROOMS WALL SHEETS (INCL BATHROOM / TOILET AND OFFICES) | | | | | | | | | | | |
