SPECIAL PURPOSE REPORT

DATE OF INSPECTION

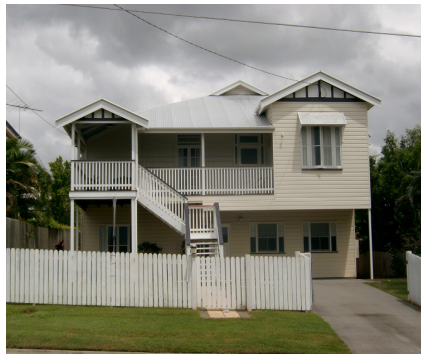
Client/Property Address:

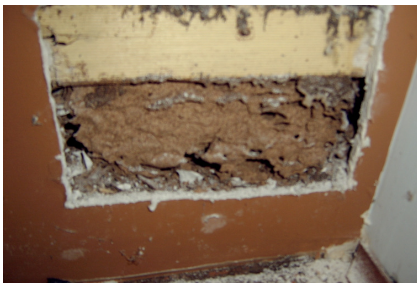
Termite mud packing to wall cavity which was discovered with the borescope & then an inspection point was cut to reveal the damaged timbers.
